TROUBLE RECOVERY AND MAINTENANCE OF AMPLIFIER POWER SUPPLY FOR HIMAC INJECTOR LINAC

T. Takeuchi, T. Fujimoto, Y. Honda, Y. Kageyama, M. Kawashima, C. Kobayashi, I. Kobayashi, Y. Takahashi, W. Takasugi, H. Uchiyama, M. Yamamoto, Accelerator Engineering Corporation, 2-13-1 Konakadai, Inage-Ku, Chiba-shi, 263-0043, Chiba, Japan
 Y. Iwata, E. Takada, National Institute of Radiological Science, 4-9-1 Anagawa, Inage-Ku, Chiba-shi, 263-8555, Chiba, Japan

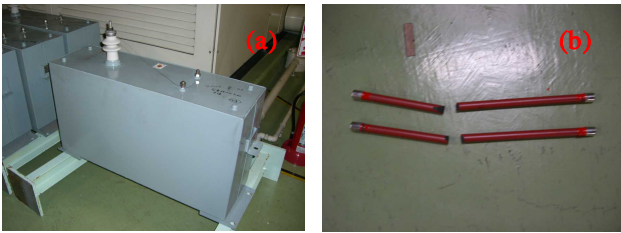
cancer treatment, while the night and weekends are used for experimental studies of physics and biology. According to the alarm message for this trouble, the source of the trouble is either HPLT_D or HPA. In order to discriminate it, we tried the turn on of HPLT_D without loads. The result was that HPLT_D could not be turned on nor generate the high voltage. From a visual inspection of the inside of the HPLT_D cabinet, we found a short-circuited capacitor and accompanying two resistors broken as shown in Fig. 3 (b). All of resistors for the other of capacitors were normal. Under the condition of capacitance of 9 parallel (270 μ F), the voltage drop rate is estimated as less than 5 % and is sufficient to obtain RF power to accelerate C^{2+} ions (650-700 kW). Since the cancer treatment should be resumed as quickly as possible, we determined to drive the HPLT_D under the condition of 9 parallel capacitors. Therefore, we separated the short-circuited capacitor from the capacitor bank line and restarted DTL operation. The down time of the beam supply was a half hour.

Fig.3. (a) Capacitor for HPLT_D (b) Broken resistors

The schematic drawing of the capacitor bank circuit is shown in Fig. 6. If a capacitor becomes short-circuited for some reason, all amount of stored electric charges in others run through the short-circuited capacitor. Then the attached resistors (R7) are broken in the heating by the high current; these resistors play a role of the fuse. In view of the fact that attached resistors of a short-circuited capacitor were broken, it seems that the mechanism described above happened. The reason of this phenomenon that the capacitor becomes short-circuited is uncertain but is guessed to be the decreasing of the rated lifetime by the degradation of capacitors. In general, the lifetime of the capacitor strongly depends on the repetition times of charge and discharge, the environmental temperature, and impressed voltages. Every capacitor in HPLT_D has been in use for 5 years since 2001. Further discussion is given in the next section.

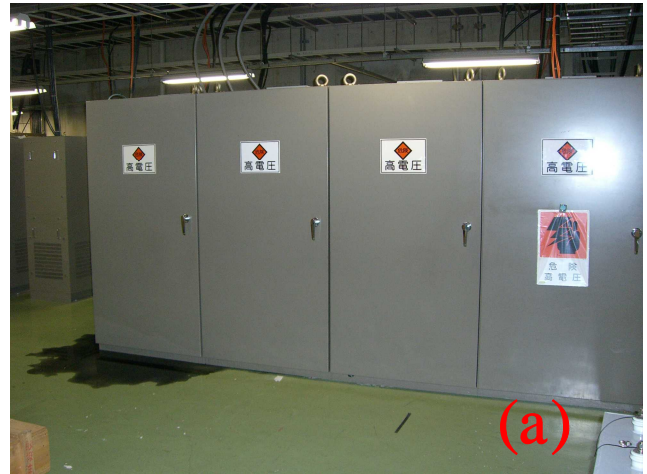
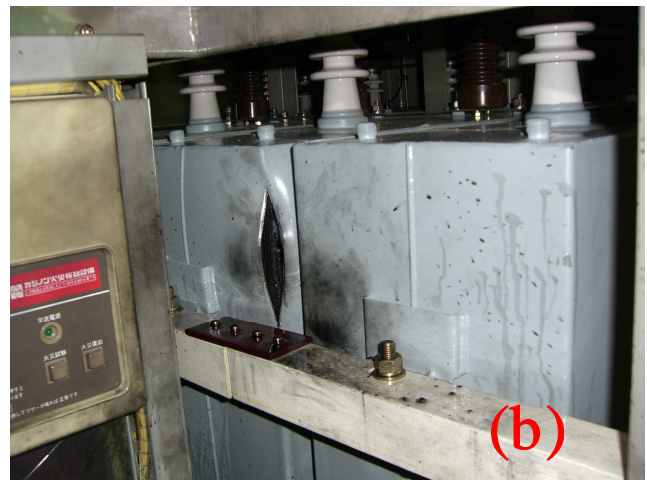
Second incidence of the trouble about HPLT_D happened at a midnight of two days later. We have confirmed the foul smell of burned-out oil at the power supply room and the leaking of the enclosed oil from one of the capacitors as shown in Fig. 4 (a) and (b). It was clear that we had to change the capacitor again for the normal operation. And we need it be completed by the next morning, when the cancer treatment resumes. On the other side, an experiment at Biology area happened to stage the 2nd day of three day fractionated irradiation. Thus we had to decide when and how long we stop the beam and work on the recovery of the machine. We reached a conclusion by subtracting estimated necessary time from the 7am time limit, as indicated in Table 2.

Fig. 4. (a) HPLT_D and oil leakage (b) Burst Capacitor

We tried to measure the output voltage of HPLT_D on the condition of no-load at the Monday maintenance time of the following week. Table 3 shows measured voltages as a function of the variable tap on the transformer. At the time of trouble, the setting voltage of the variable tap on the transformer was 21 kV. This corresponds to the measured voltage of 24 kV. Taking into account of effects of the exciting voltage by RF operation and the lifetime of capacitor, the actual voltage is well over the rated voltage for the capacitors which is typical of 24 kV and maximum of 30 kV for 1 minute. It is considered that the excess voltage condition inside the capacitor gives rise to the electrical discharge and the burst of the capacitor. As the specification for the impressed voltage of HPLT_D is of about 23.5 kV, we changed the variable tap to the setting voltage of 18 kV.

We immediately carried out the cleaning of the interior of HPLT_D and the separation of a burst capacitor. Before scheduled time (1:00 am), the restart of the beam supply to experiment users was achieved. After the beam supply of about two hours to experiments, we went on to work the replacement in a spare capacitor of the separated one and preparations for the medical treatment. All of recovery works were completed by 6:30 am.

was necessary to increase the gain of HPA. Therefore, the setting voltage of variable tap had been set to 21 kV. As it is expected to have caused the decrease of the lifetime of capacitors, we carried out the replacement of all capacitors to brand-new ones. The work has already been finished at Spring 2007.

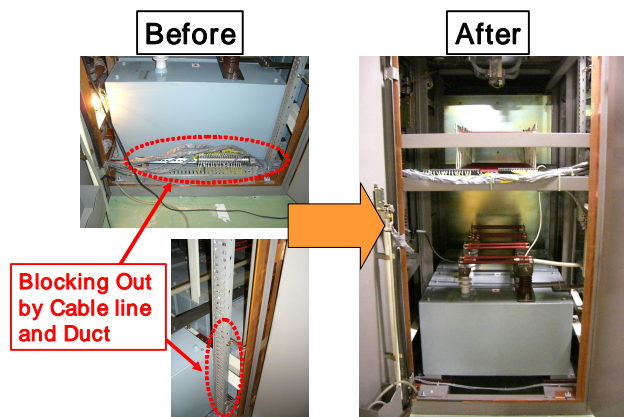
Fig. 7. The remove of the cable line and duct which is blocking out the replacement of the capacitor.

The enhancement and improvement of the maintenance for HPLT_D is necessary. The precise measurement of the capacitance and the voltage are added in the maintenance procedure for HPLT_D. In order to increase the working efficiency and to shorten time for the replacement of capacitor, we modified the exterior of HPLT_D as shown in Fig. 7. We removed the cable line and duct which is blocking out the replacement work of the capacitor.
