TROUBLE RECOVERY AND MAINTENANCE OF AMPLIFIER POWER SUPPLY FOR HIMAC INJECTOR LINAC

T. Takeuchi, T. Fujimoto, Y. Honda, Y. Kageyama, M. Kawashima, C. Kobayashi, I. Kobayashi, Y. Takahashi, W. Takasugi, H. Uchiyama, M. Yamamoto, Accelerator Engineering Corporation, 2-13-1 Konakadai, Inage-Ku, Chiba-shi, 263-0043, Chiba, Japan
 Y. Iwata, E. Takada, National Institute of Radiological Science, 4-9-1 Anagawa, Inage-Ku, Chiba-shi, 263-8555, Chiba, Japan

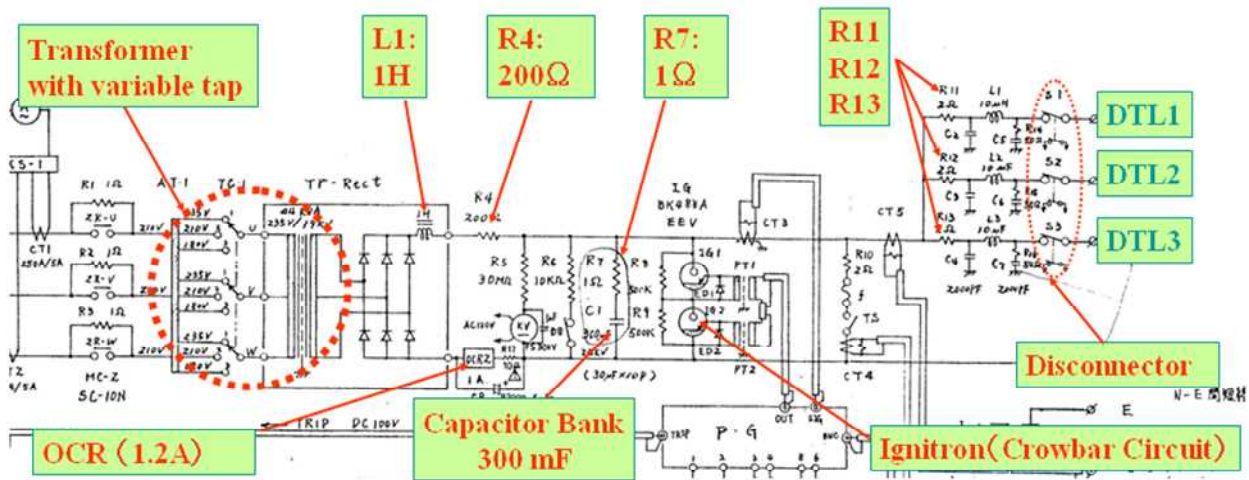
Fig. 5. Main part of HPLT_D circuit

Figure 5 shows the diagram of HPLT_D main circuit. Three-phase voltage of 200 Vac is boosted by the transformer with variable tap and is also changed to the direct current by the next rectifier. The direct current is charging the capacitor bank (C1) through a reactor (L1) and resistors (R4 and R7). L1 has a role of the suppression for the incoming current. Also R4 protects the rectifier from the supply current and voltage. Each one of the capacitors is accompanied by two resistors (20

Ohm) which are connected in parallel as shown in Fig. 6. The capacitor bank is responsible for supplying the current to compensate the voltage sagging by the DTL pulse operation.

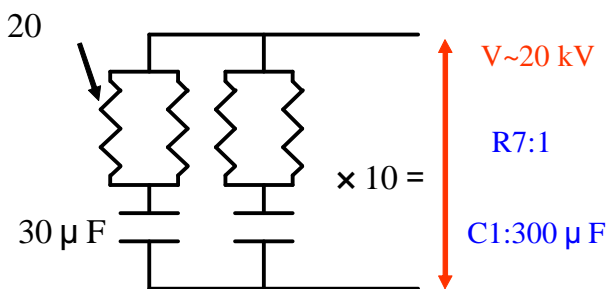
Fig. 6. The schematic drawing of the circuit around the capacitor bank

The schematic drawing of the capacitor bank circuit is shown in Fig. 6. If a capacitor becomes short-circuited for some reason, all amount of stored electric charges in others run through the short-circuited capacitor. Then the attached resistors (R7) are broken in the heating by the high current; these resistors play a role of the fuse. In view of the fact that attached resistors of a short-circuited capacitor were broken, it seems that the mechanism described above happened. The reason of this phenomenon that the capacitor becomes short-circuited is uncertain but is guessed to be the decreasing of the rated lifetime by the degradation of capacitors. In general, the lifetime of the capacitor strongly depends on the repetition times of charge and discharge, the environmental temperature, and impressed voltages. Every capacitor in HPLT_D has been in use for 5 years since 2001. Further discussion is given in the next section.

was necessary to increase the gain of HPA. Therefore, the setting voltage of variable tap had been set to 21 kV. As it is expected to have caused the decrease of the lifetime of capacitors, we carried out the replacement of all capacitors to brand-new ones. The work has already been finished at Spring 2007.
